ENGINEERING SEISMIC INVESTIGATION

VILLAGE OF PAGUATE, NEW MEXICO

Administrative Report

August 29, 1986

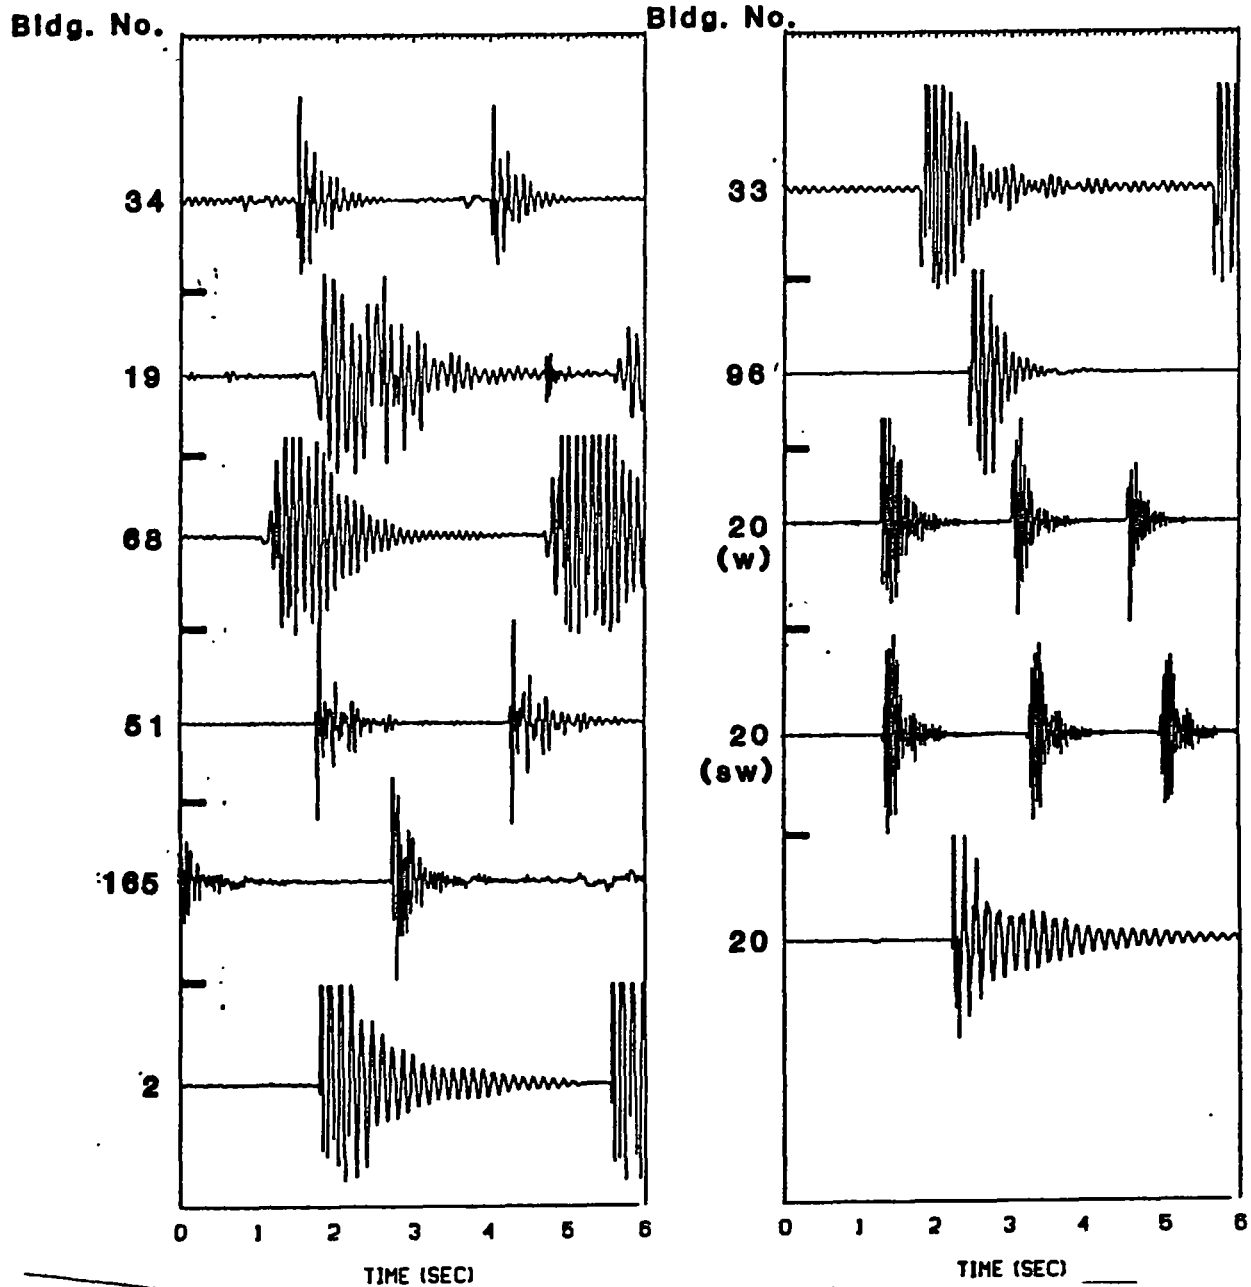
Figure 3.--Time-histories for man-induced vibrations measured on the top-midpoint of the bearing walls for the buildings listed on the left of the seismic record.

where β is the percent critical damping and X_n is the velocity amplitude for the n th cycle of motion. The natural periods of the walls were picked as the peak of the response spectra (fig. 4). The natural frequencies varied from 5 to 14 Hz with damping varying from 1.5 percent to approximately 9 percent (table 2). The periods and damping values are in the normal range for the "Chaco"-type structures (King and Algermissen, 1985).

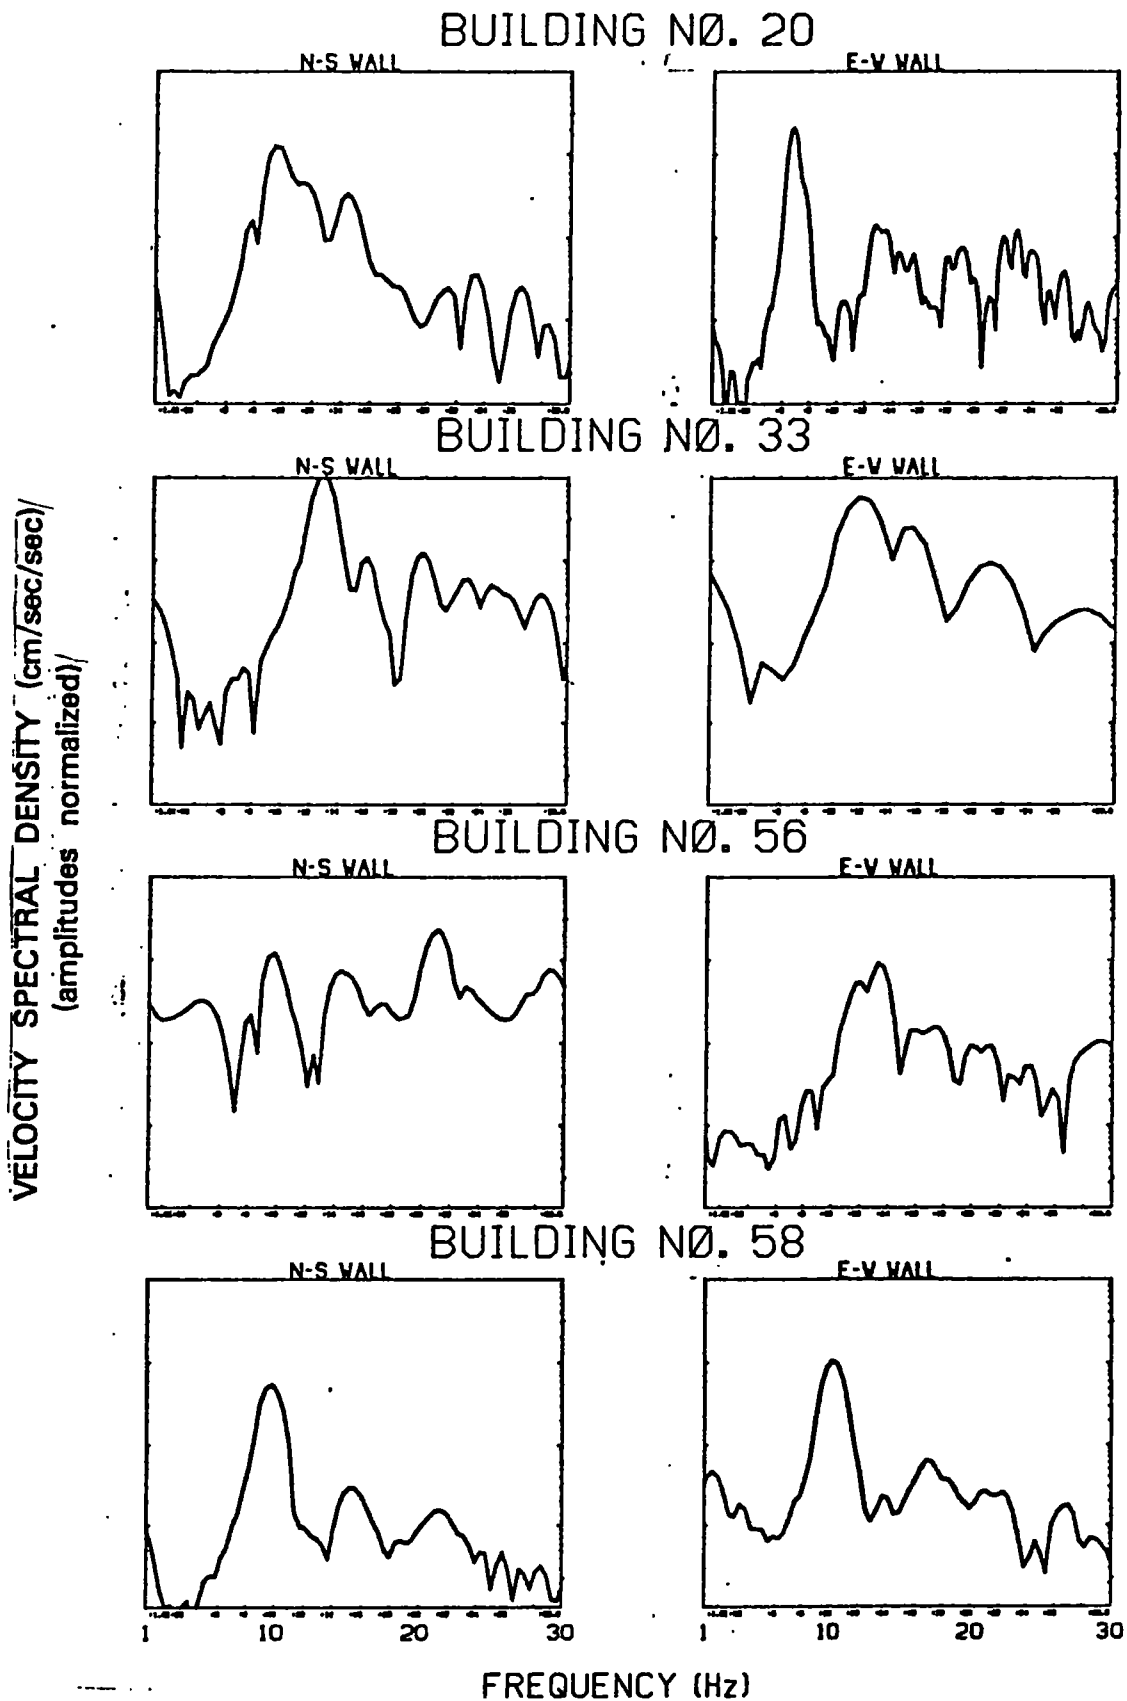
Figure 4.--Normalized spectra for north-south and east-west walls of 4 buildings. Spectra are derived from recordings of man-induced seismic energy applied directly on the walls.

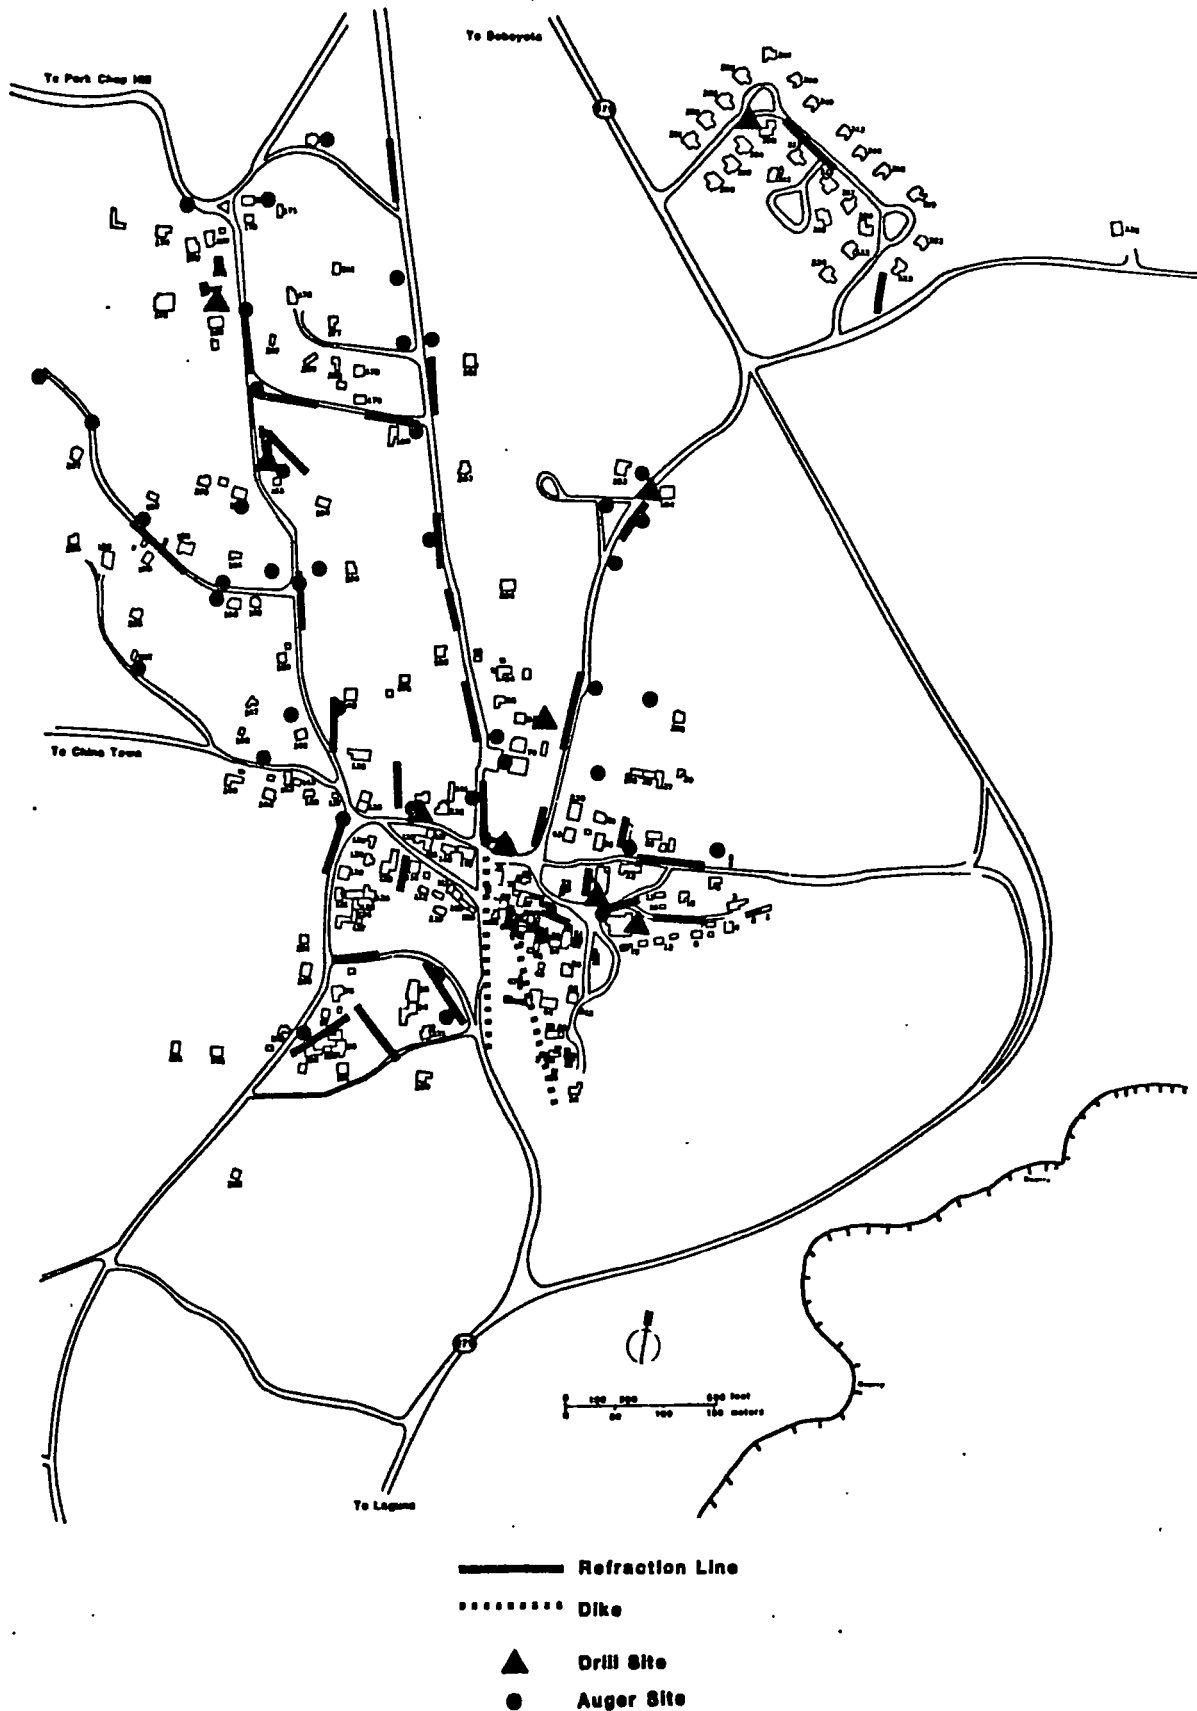
Forty test borings were completed within the village of Paguate together with 25 shallow refraction surveys. The locations of the test borings and refraction lines are shown in figure 5. The data from the borings and the refraction lines were used to map the thickness of the low seismic velocity material underlying the village. Ten core samples 5-10 inches (2-5 cm) in length were recovered from the boreholes. The core samples were analyzed for grain size, sand/clay ratios, void percentages, and any evidence of a perched or changed water table (staining, water content, etc.) (table 4). The percent core recovered versus percent cored was documented. The core loss due to compaction and the void ratios give an indication of the differential compaction potential. Sections of the foundations under a damaged bearing wall were exhumed and inspected for evidence of distortion and/or displacement.

Of the test borings, thirty were made to measure the thickness of sediments and soils over the bedrock underlying the village. The data from the borings along with the refraction-survey results show that the thickness of the unconsolidated sediments and/or materials with a propagation velocity

Figure 5.--Seismic study in the Paguate area showing drill and auger test locations, lines of refraction and alignment of exposed rock dikes.

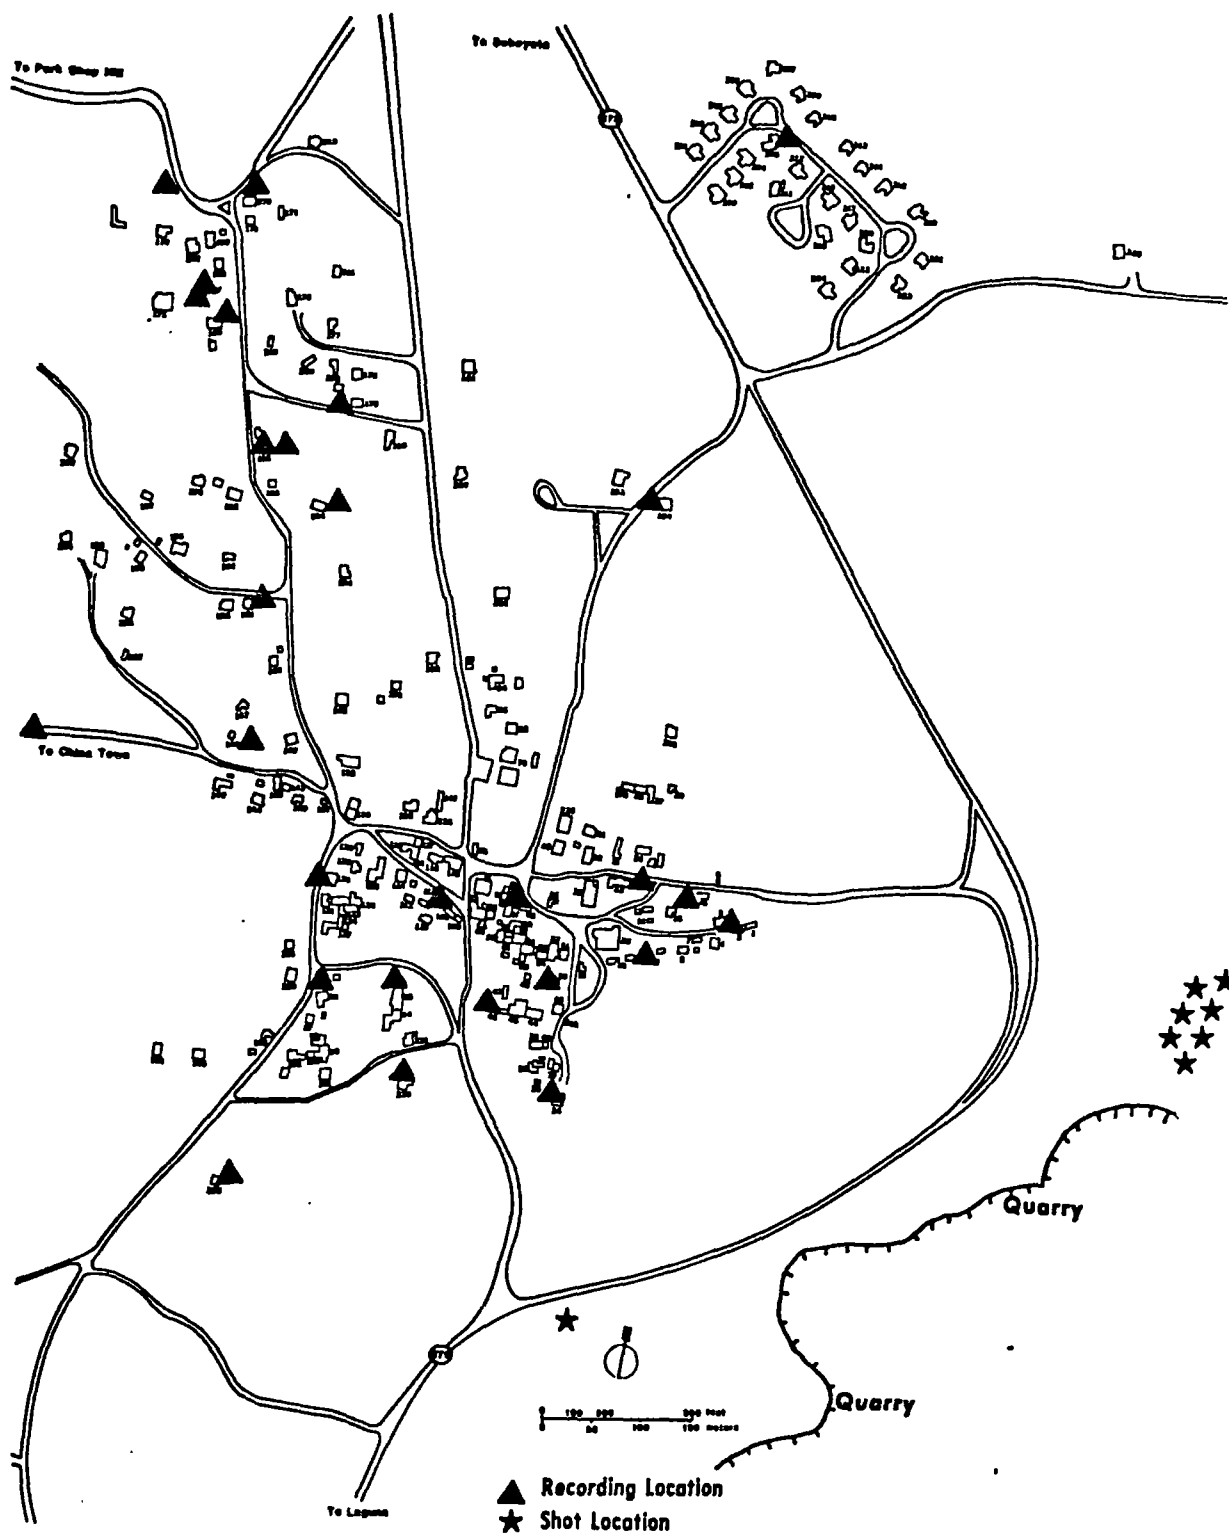
Figure 7.--Seismic study in the Paguate area showing shot and recorder locations.

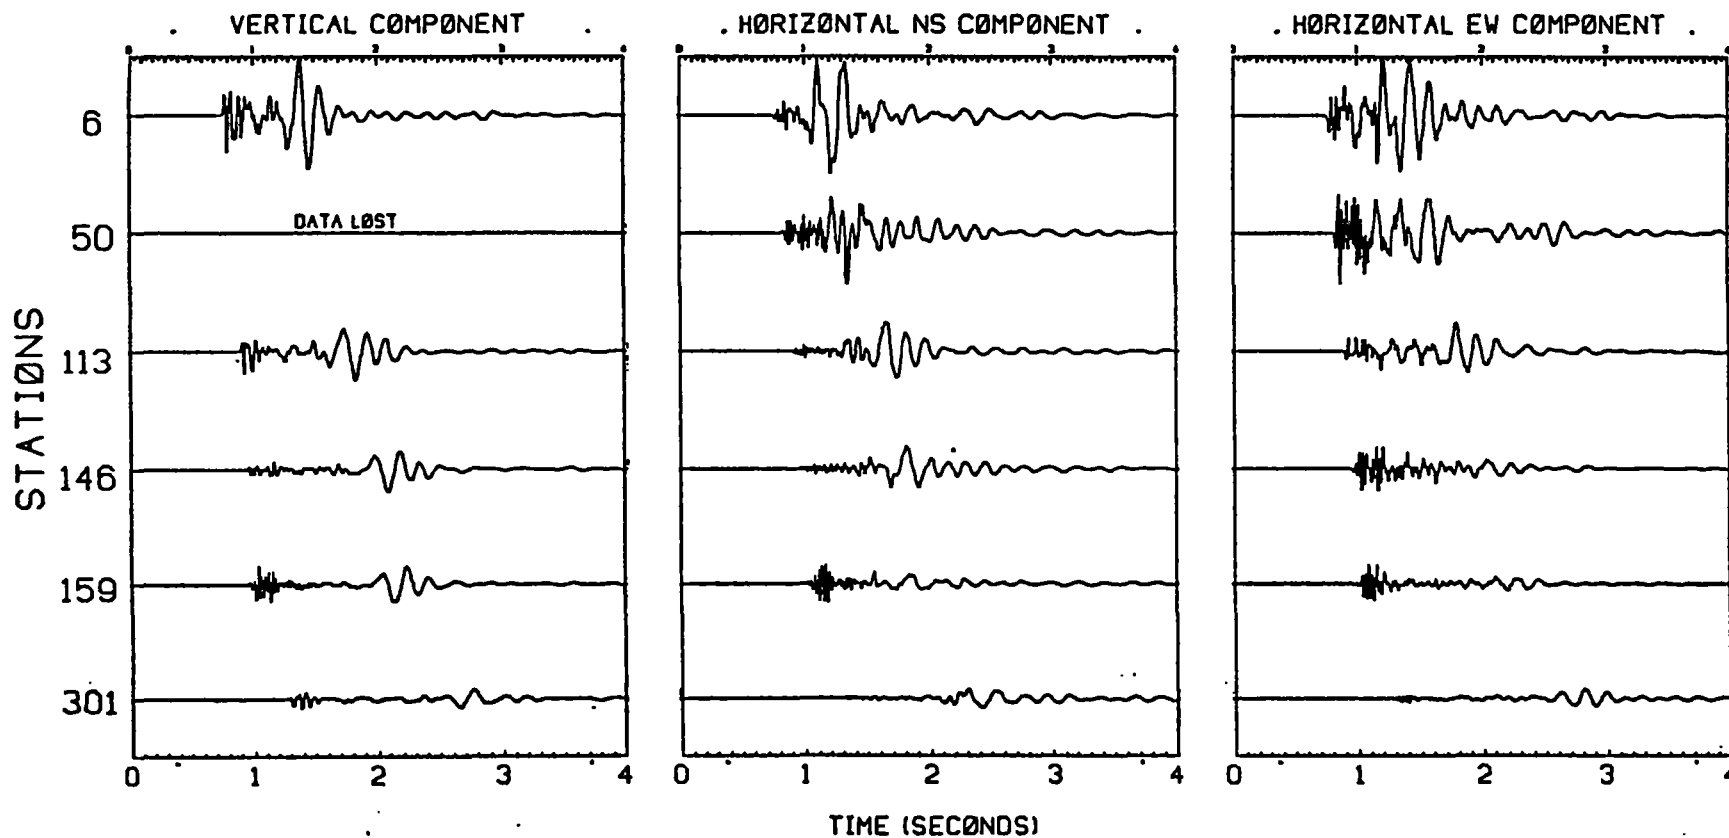
response effects) and at similar bearings but in different distance ranges from the source (from 2,150 to 5,240 feet; 655 m, 1,047 m). Analysis of the seismic data induced from the explosions (figs. 8 and 9) yielded the peak particle and velocity spectral ground motion attenuation values throughout the village. An equation of the form of $A = cR$ where A is the amplitude in cm/s (peak particle ground motion in velocity) or cm/s/s (spectral velocity density), c is a constant, and R is the explosion-to-site distance that was used to fit the attenuation data to the equation by least-squares regression. The relationship obtained is $A = cR^{-1.87}$ for peak particle, vertical ground-motion velocity and $A = cR^{-1.15}$ for peak particle, horizontal ground-motion velocity. The ground-motion, spectral-velocity, attenuation-scaling functions are similar to the peak particle scaling function except that the spectral attenuation is scaled for a range of frequencies between 1-15 Hz (fig. 10).

Figure 8.--Three-component time-histories of the test explosions recorded at 6 buildings in the village of Paguate.

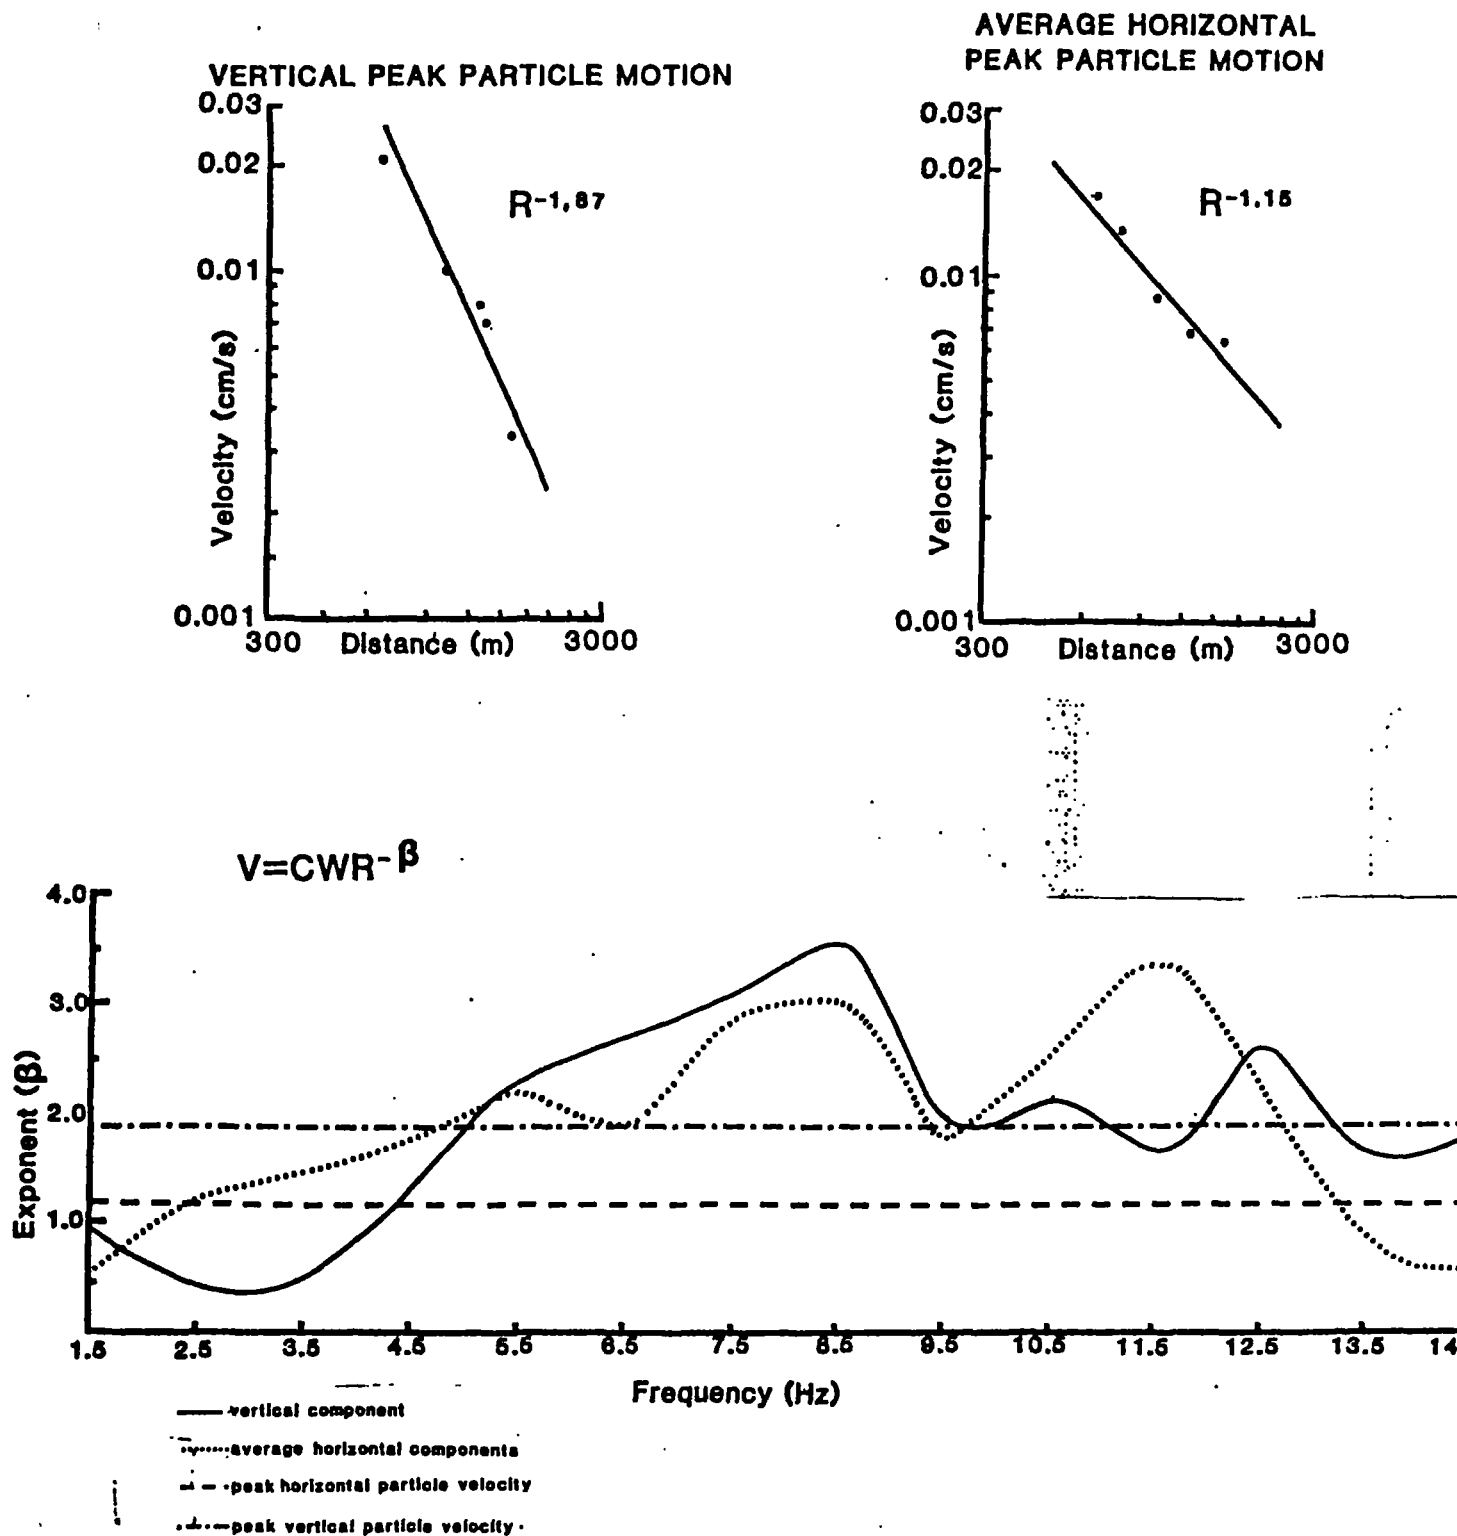
Figure 10.—Upper two graphs show the attenuation data. Bottom graph shows the attenuation for the average horizontal and vertical components where V = ground motion in cm/s; C = constant; W = yield in pounds; R = distance from the event in meters; β = slope of regression line.

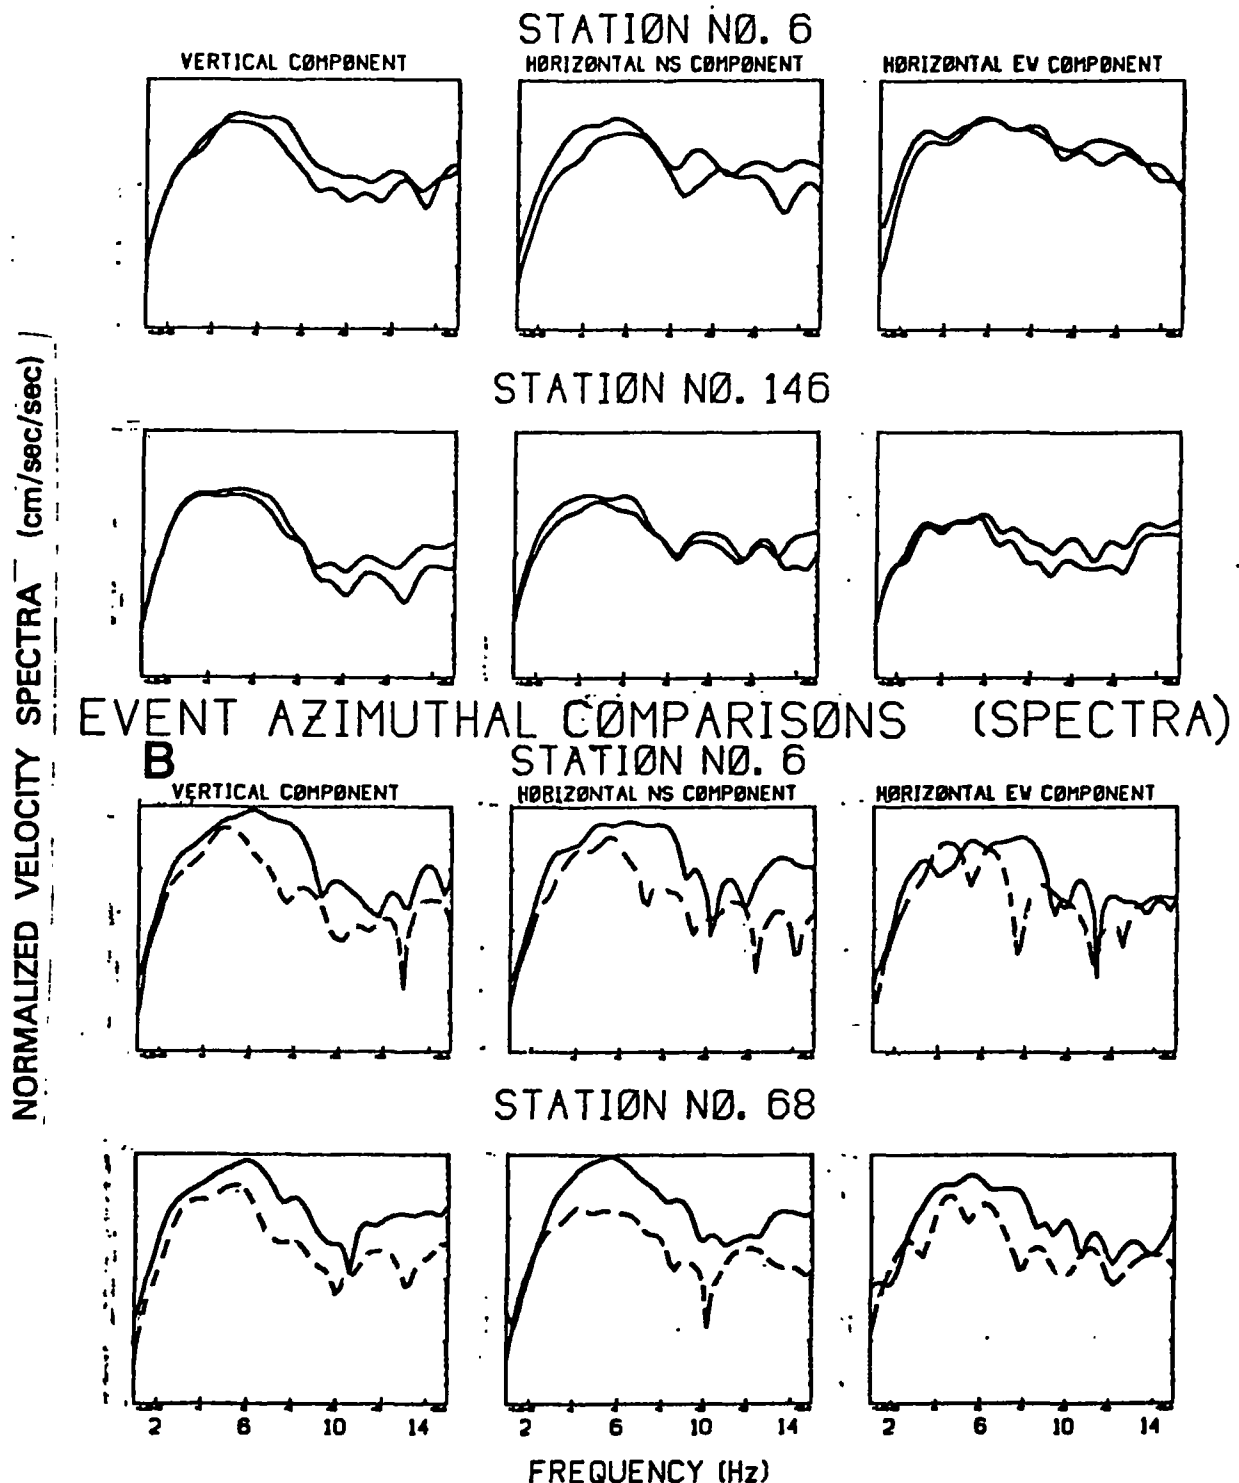
The spectra derived from the ground motions recorded at sites 6 and 146 from the test explosions east of the village are also used to calibrate the variations of the input sources. The highest and lowest spectral values at these sites are shown on figure 11a. The difference between the spectra are small since the test explosions were of the same approximate size, distance, and bearing from the recording sites. A similar comparison is made for sites 6 and 68 to document the variations of the input sources which are located east of the village against the input sources of the event located south of the village (fig. 11b). The ground motion variation due to difference in bearing of the test explosions shown on figure 11b is larger than that on figure 11a due to the larger difference in the distances from the events; however, the general spectral shape is similar. The comparisons indicate that the data from the east test explosions are, in general, comparable from one event to another. The comparison of the events at different bearings indicate that within the bearing variations that were tested, there were no large variations in the recorded ground motions associated with azimuth.

Figure 11.--(A) Test explosion variations are small as shown by the small variation in the ground motion spectra. The highest and lowest spectral values recorded at site 6 and 146 are shown. (B) Shows the variation in spectral values obtained from explosions east of the village (solid lines) to those south of the village (dashed lines).
